PAINT MINE ID TEAM

Subject: Sunshine Quartz/Hematite Claims Project – Exploration and Development,
Data/Information Needs for the Environmental Analysis and Evaluation Process

Figure 1
Extended Phase 1 Site Location Map
Sunshine/Hematite Claims Project
Addendum #3 to POO, Dec. 1997
Uintah Mountain Copper Company

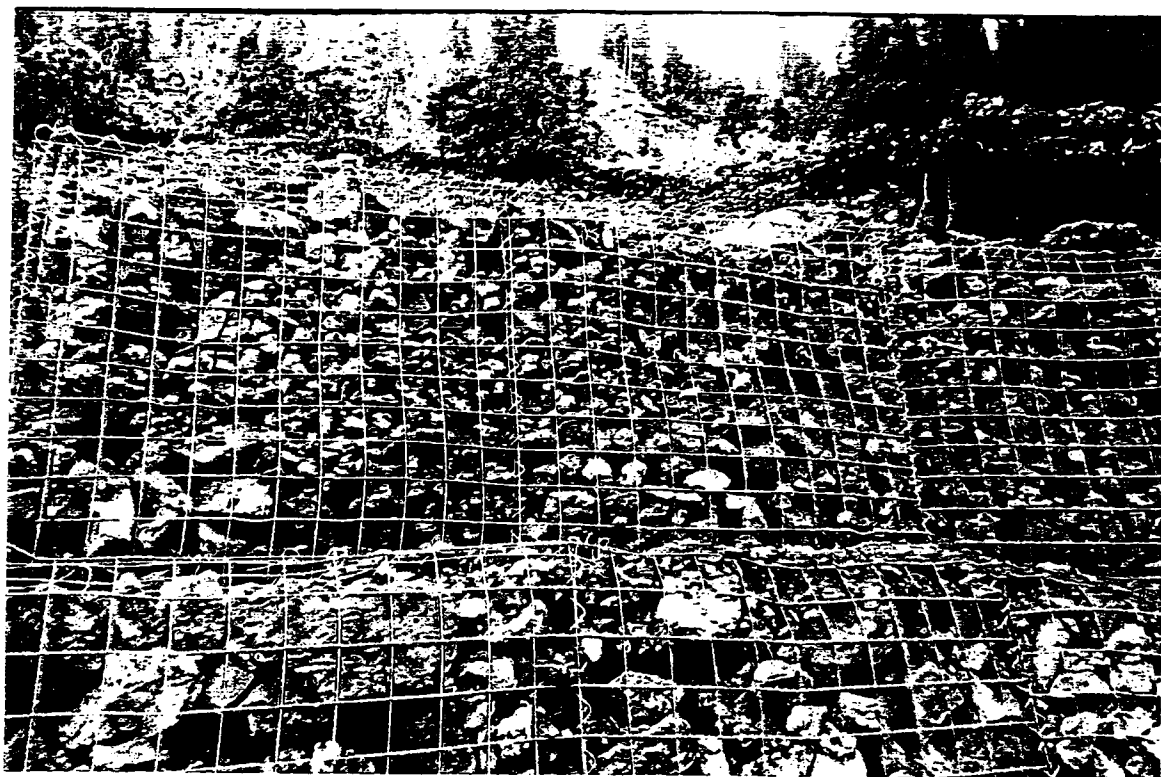
Photo F - Gabion Basket Wall Rock Fill

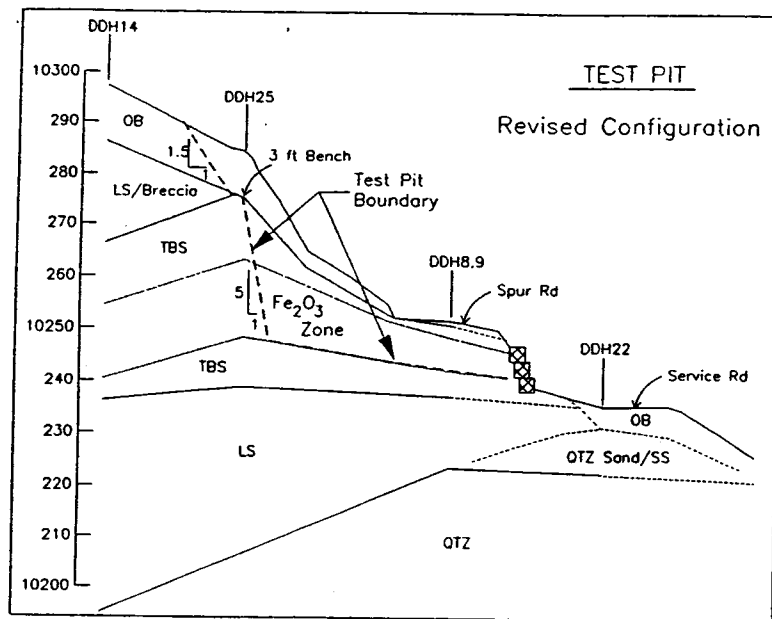
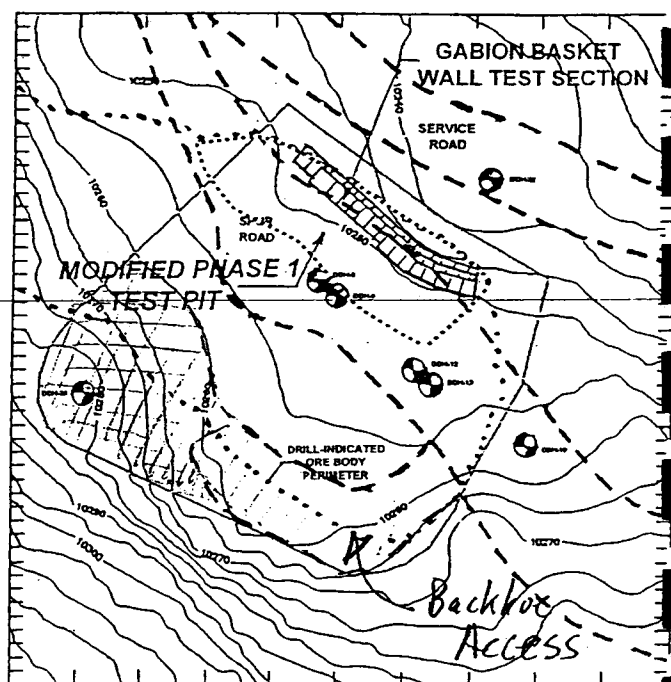
Figure A

**Revised Test Pit Configuration
Staged Excavation
Overburden Removal**

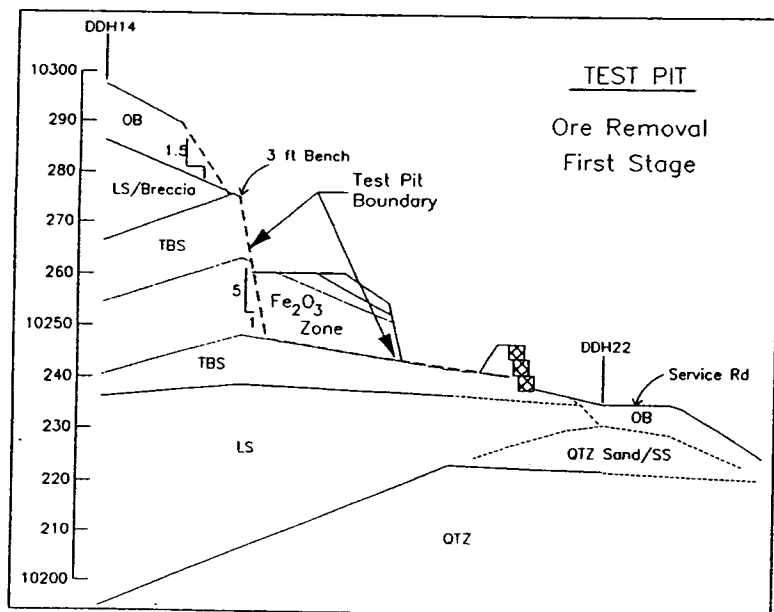
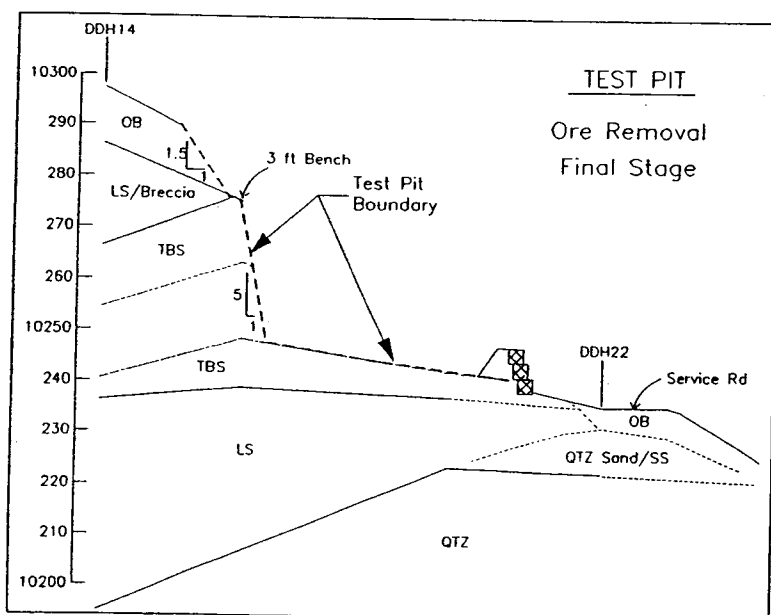
Figure B
Revised Test Pit Configuration
Staged Excavation
Ore Removal

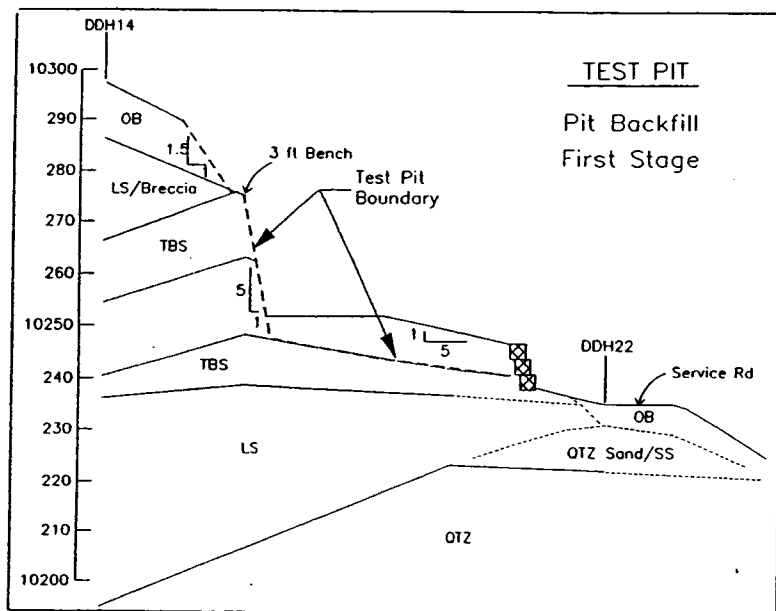
Figure C

**Revised Test Pit Configuration
Staged Backfill Work
Lower Gabions**

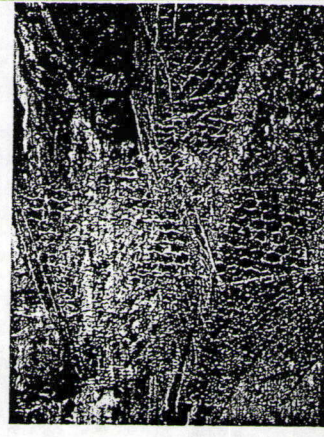
Figure 1. Gabions Containers (rock baskets)

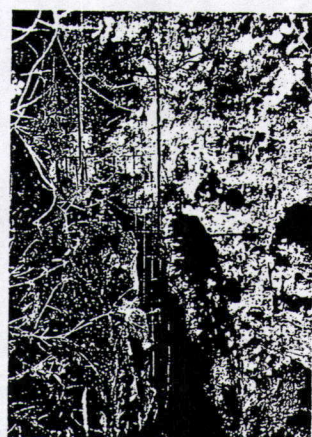
Figure 2. Rebar-Mesh Washout Repair

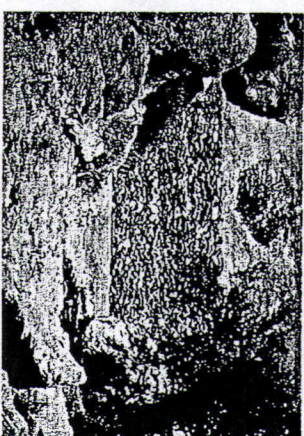
Figure 4. Gabion Repair on Concrete Pad

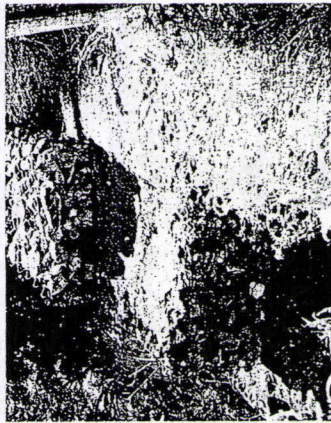
Figure 5. Single Gabion Lowered for Spillway

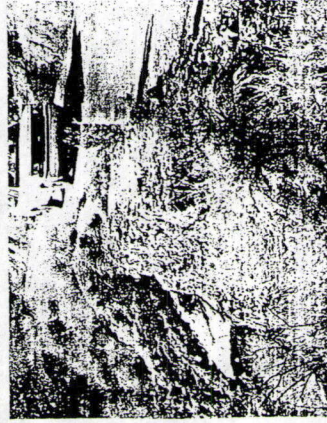
Figure 6. Gabion Structure Lowered for Spillway

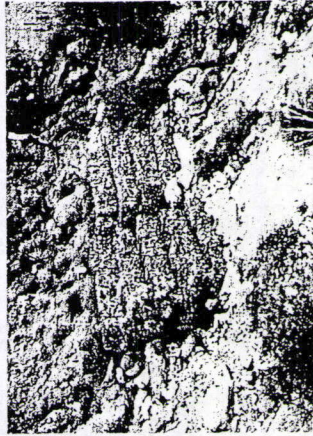
Figure 9. Road Edge Gabion Stabilization - 1998

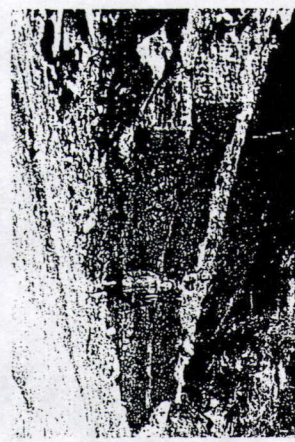
Figure 13. Reclamation Gabion Stabilization September 1997

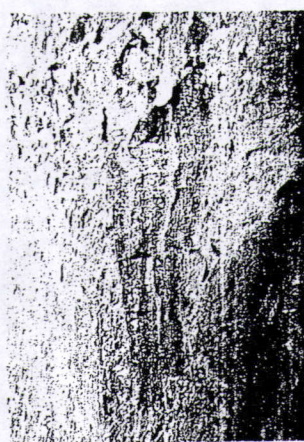
Figure 14. Reclamation Gabion Stabilization August 1998

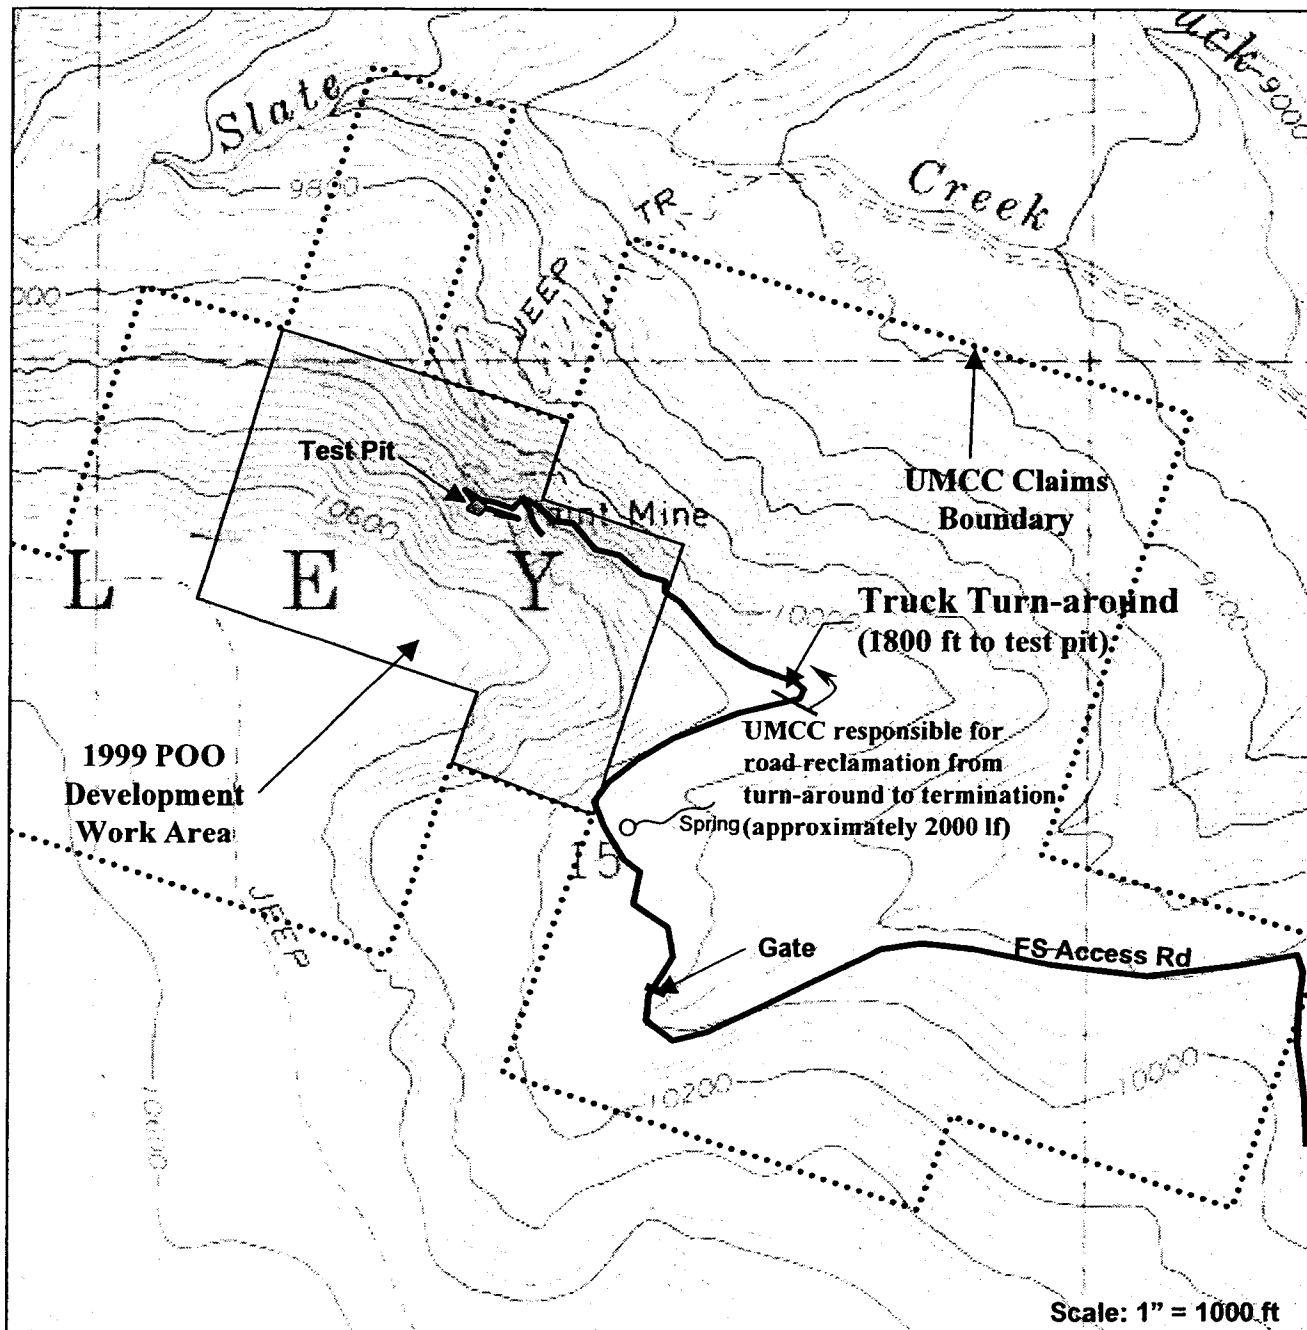
Sample Ore Transport Route Map

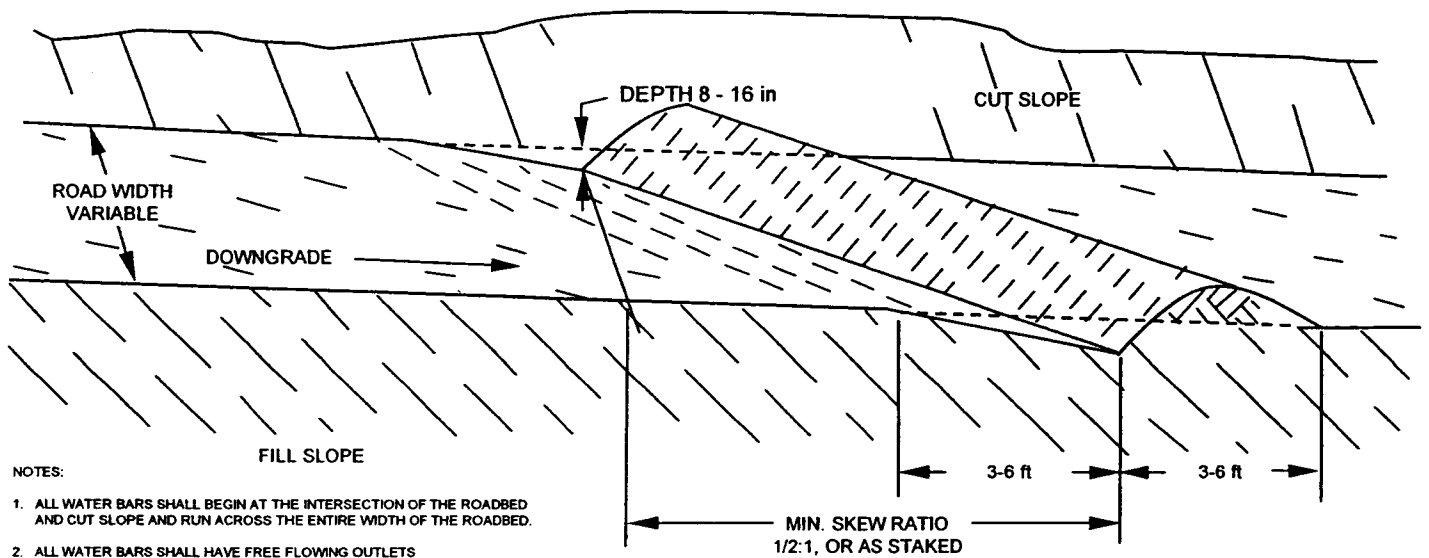
STANDARD DETAIL FOR WATER BAR

(adapted from USDA FS Wallowa-Whitman NF standards)

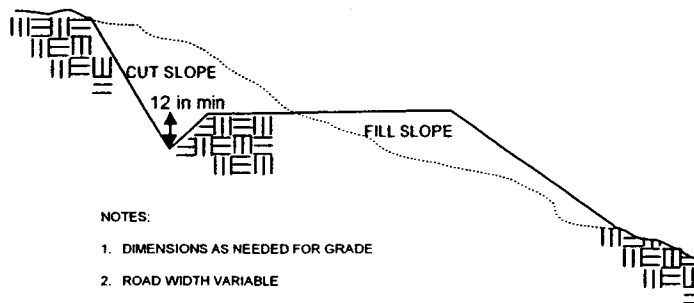
STANDARD ROAD CROSS SECTION W/DITCH

(adapted from USDA FS Wallowa-Whitman NF standards)

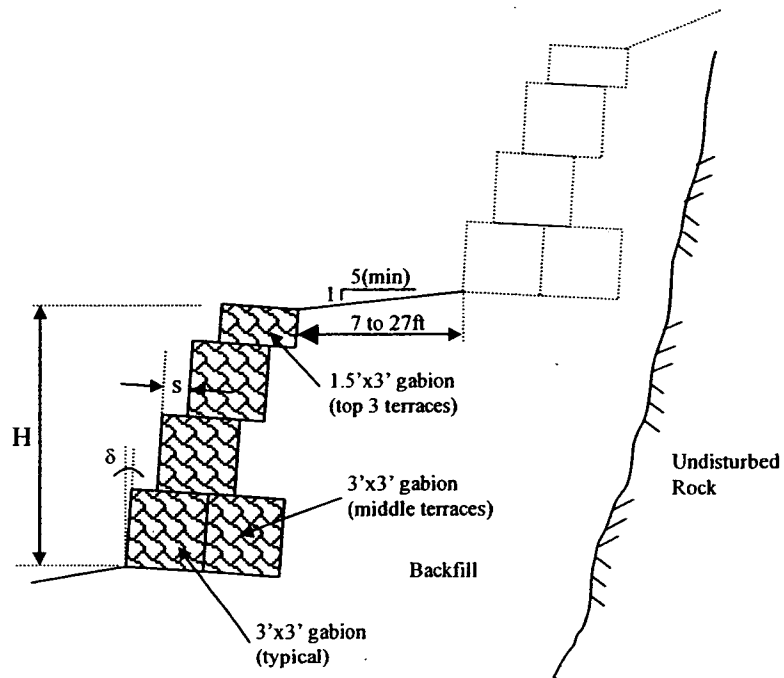
Wall height, H , varies from 8 to 10.5 ft
 Gabion baskets stagger, s , 12 ± 3 inches
 Wall inclination at time of construction, $\delta = 10^\circ$ to 15°

Illustration of Typical Gabion Rock Wall Section
